HERMITAGE

PRESERVATION THROUGH RESTORATION

LOVERS LANE
ANCASTER

RESTORATION HERMITAGE

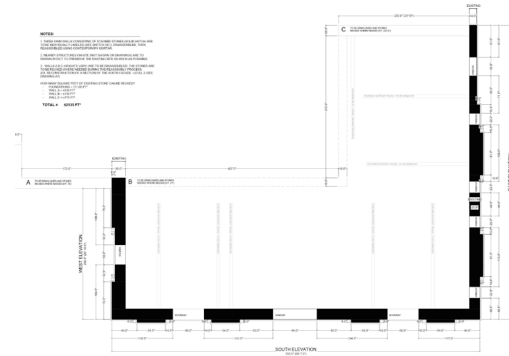
Heritage, Main Loop Trail, Ancaster, L9G 4T7
LEVEL 1 - Existing
1:100

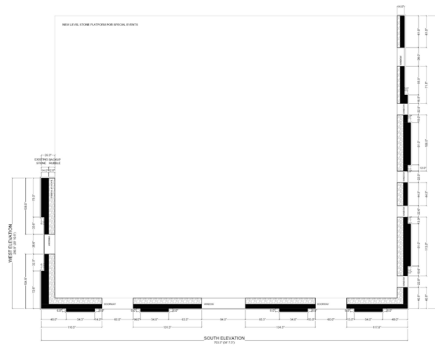
Heritage, Main Loop Trail, Ancaster, L9G 4T7
LEVEL 1 - Proposed
1:100

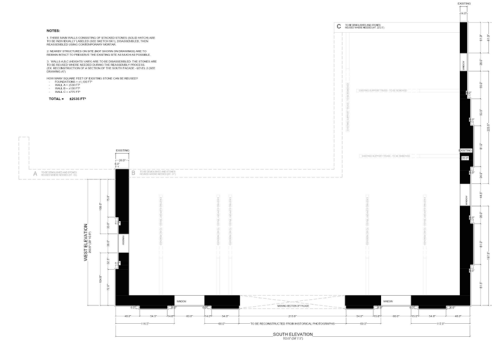
Heritage, Main Loop Trail, Ancaster, L9G 4T7
LEVEL 2 - Existing
1:100

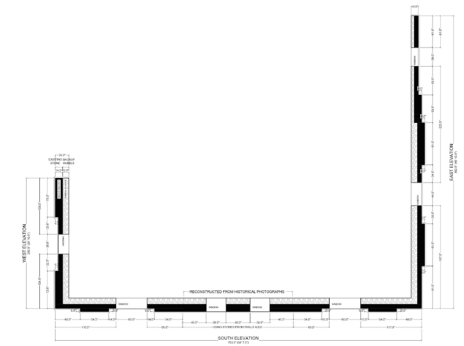
Heritage, Main Loop Trail, Ancaster, L9G 4T7
LEVEL 2 - Proposed
1:100

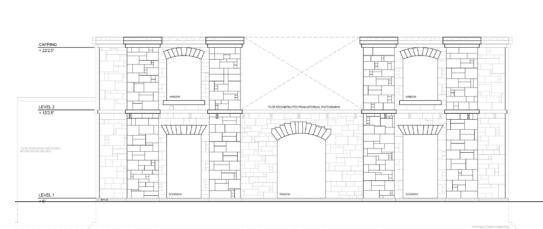
Heritage, Main Loop Trail, Ancaster, L9G 4T7
SOUTH ELEVATION - Masonry Layout
1:100

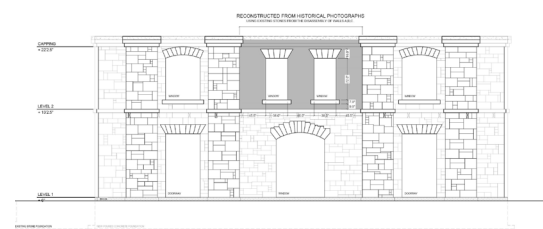
Heritage, Main Loop Trail, Ancaster, L9G 4T7
SOUTH ELEVATION - Proposed
1:100

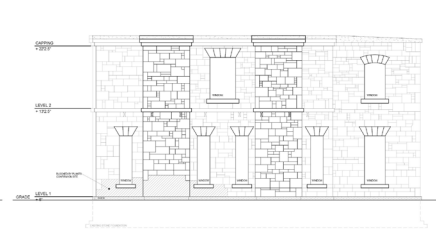
Heritage, Main Loop Trail, Ancaster, L9G 4T7
EAST ELEVATION - Masonry Layout
1:100

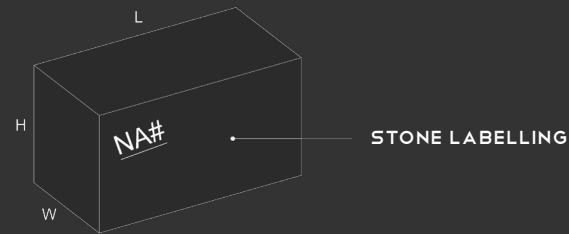
FACADE FACE OF THE STONE

LABEL A - DONE BEFORE ANY DISASSEMBLY
 LETTER 1 + LETTER 2 + NUMBER + A LINE BELOW TO INDICATE:
 Facade the Stone came from + Column + Stone location

EX. SA1 (South Facade, Column A, Stone Number 1)
